**PHASE I ENVIRONMENTAL SITE ASSESSMENT  
16 CHARLES STREET AND 50 STATE STREET  
TOWN OF PITTSTOWN, VILLAGE OF VALLEY FALLS  
RENSSELAER COUNTY, NEW YORK**

April 2024

Project # 50525

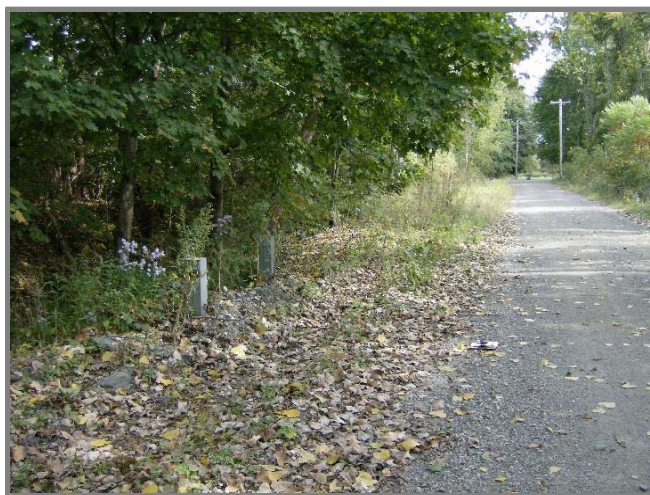
Another shot of MW-1 well pair looking northeast along the dirt road. The wells are on the left. These wells appear to be in good condition.

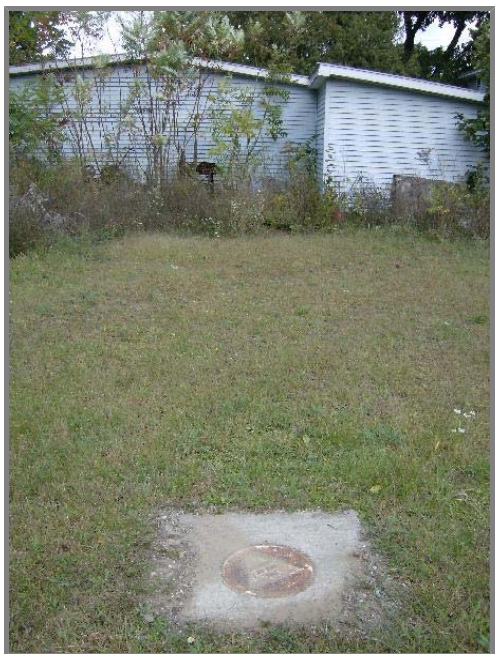
MW-2 is in the yard behind an old blue Mercedes and a brown Dodge pickup truck.  
MW-2 NYTM\_X: 617446 NYTM\_Y: 4750498  
This well appears to be in good condition.
